# Flightdeck Crew Alerting Issues: An Aviation Safety Reporting System Analysis

DOT/FAA/CT-TN94/18

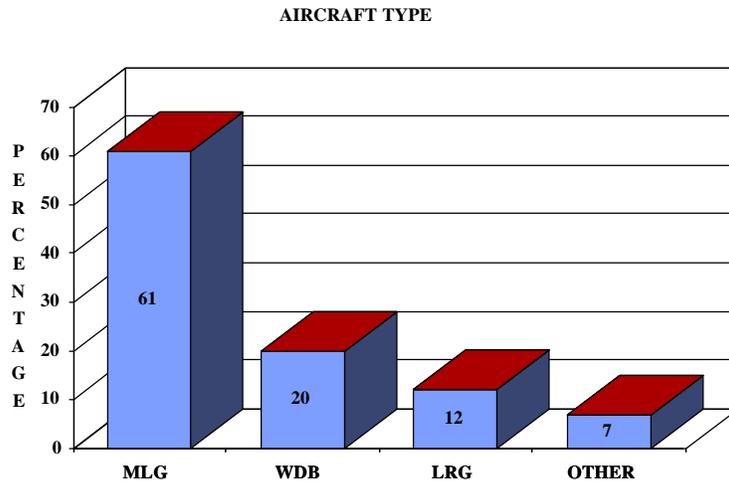
FIGURE 2. ALERTING INCIDENT AIRCRAFT TYPE

The majority of the reported incidents involved MLG aircraft. This high percentage of MLG aircraft is not surprising given the fact that the majority of the commercial transport aircraft flying in the NAS fall into this category. Figure 2 shows the different aircraft types, and their respective percentage of occurrence, within the analyzed ASRS reports.

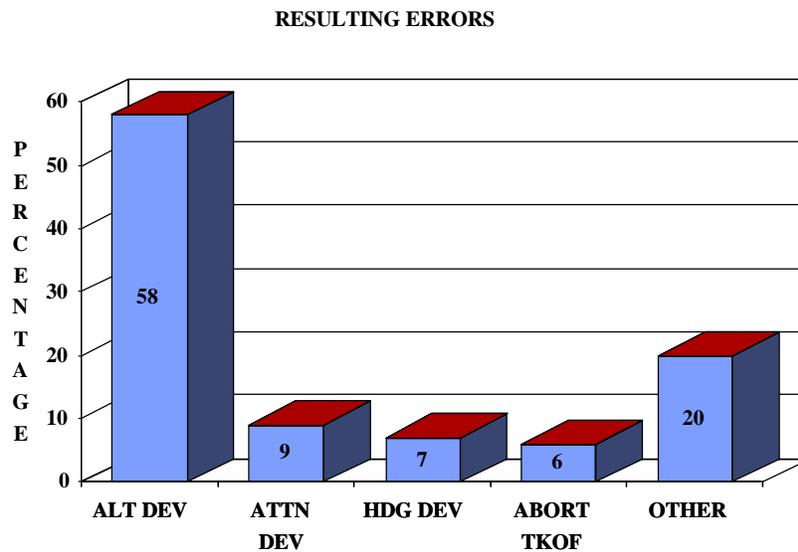
FIGURE 3. CREW ALERTING RESULTING ERRORS

the computerized error detection capabilities at FAA ARTCCs. The reported crew alerting deficiencies caused a variety of different FTEs. The major errors, along with their percentage of occurrence, are shown in figure 3. The 20 percent corresponding to 'OTHER' resulting errors represents a variety of specific errors that were caused by the alerting problems. The table in appendix A can be referenced if further information regarding these 'OTHER' resulting errors is desired.

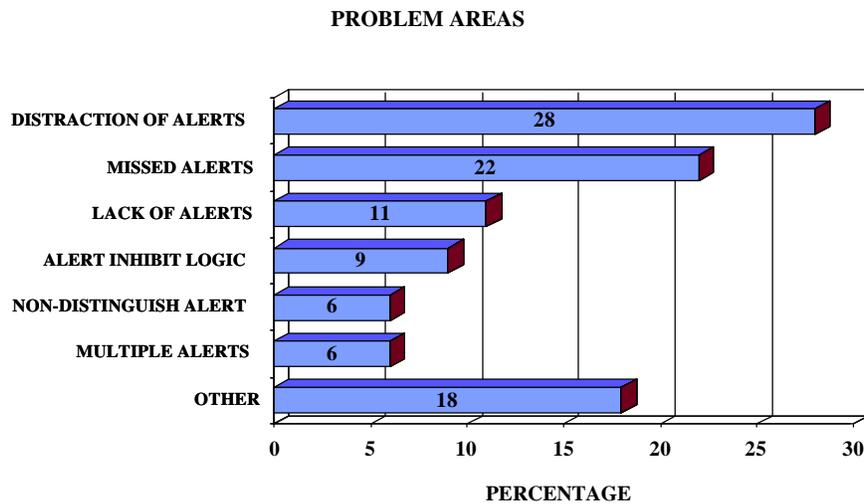
FIGURE 4. CREW ALERTING PROBLEM AREAS

While taking into account the possible lack of representation to the entire NAS, there were some significant crew alerting problem areas revealed in the ASRS database search. The majority of the incidents can be categorized into six different groups of crew alerting problems (figure 4): (1) Distraction of Alerts; (2) Missed Alerts; (3) Lack of Alert; (4) Alert Inhibit Logic; (5) Non-Distinguishable Alerts; and (6) Multiple Alerts. Each one of these categories will be individually analyzed and discussed, to define the actual crew alerting problems reported. After the results of the ASRS search are discussed, conclusions will be drawn as to their applicability to the development of crew alerting characteristics to be considered for Data Link.
